**Flood Control Project Maintenance
Levee Inspections**

Fall 2012 Levee Maintenance Deficiency Summary Report

San Joaquin River Basin

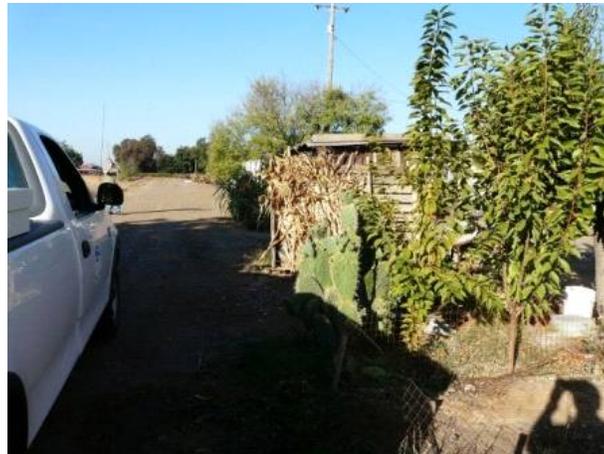
Levee Mile Report Line	126
Start Levee Mile	8.72
End Levee Mile	8.72
Location	Land Side
Category	Earthen Levee
Item	Encroachments
Building, fence and landscaping immediately adjacent to the access road at LM 8.72.	
pkazi_f_20120913_357.JPG

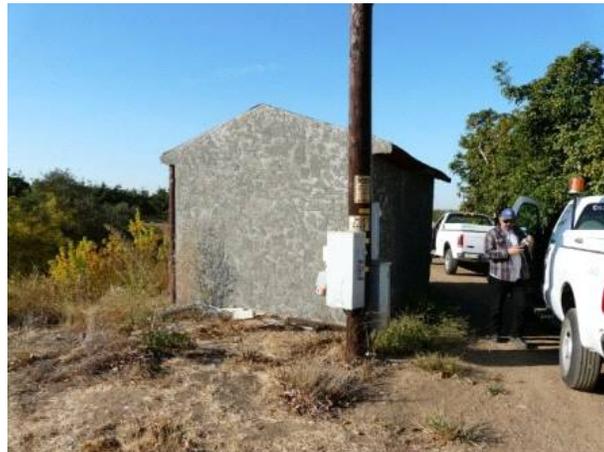
Levee Mile Report Line	130
Start Levee Mile	9.63
End Levee Mile	9.63
Location	Water Side
Category	Earthen Levee
Item	Encroachments
Building located at LM 9.63 on waterside of access road. This building appears to be recently constructed and does not currently contain anything.	
pkazi_f_20120913_323.JPG

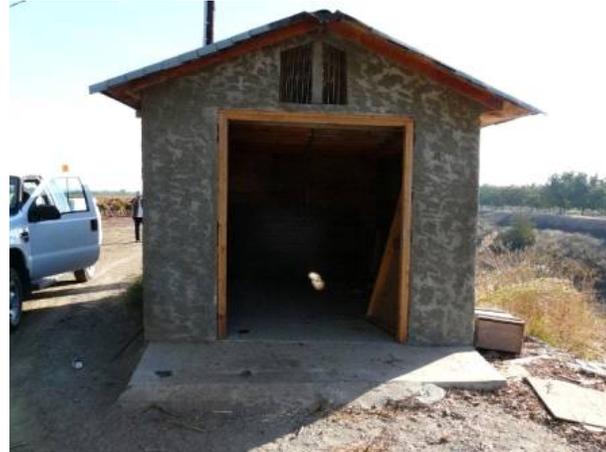
Levee Mile Report Line	130
Start Levee Mile	9.63
End Levee Mile	9.63
Location	Water Side
Category	Earthen Levee
Item	Encroachments
Additional view of building at LM 9.63.	
pkazi_f_20120913_324.JPG

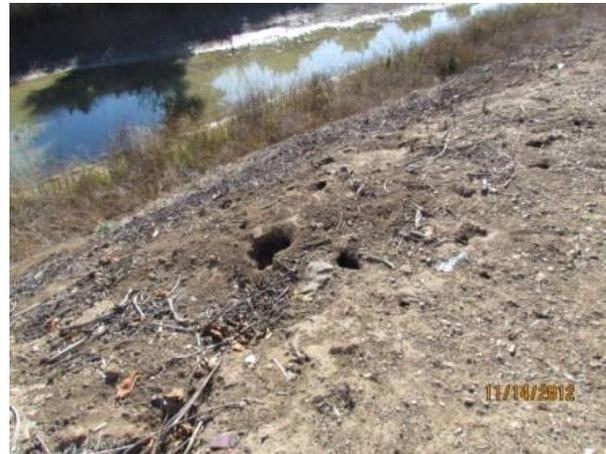
Levee Mile Report Line	133
Start Levee Mile	9.67
End Levee Mile	9.67
Location	Water Side
Category	Earthen Levee
Item	Animal Control
Animal holes were found on the waterside slope of the levee looking downstream.	
pkazi_f_20121118_079.jpg

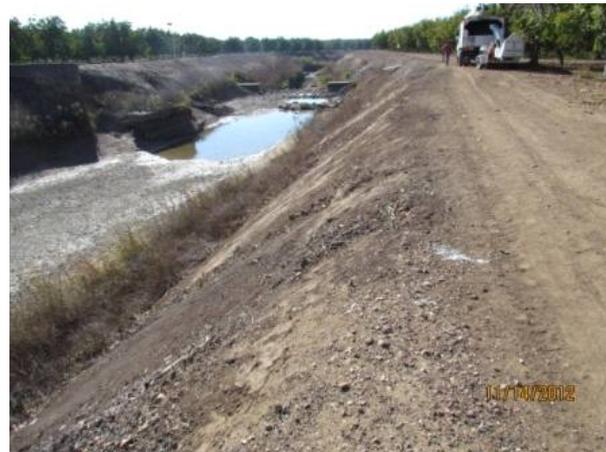
Levee Mile Report Line	134
Start Levee Mile	9.72
End Levee Mile	9.72
Location	Water Side
Category	Earthen Levee
Item	Slope Stability
Slope instability issue was repaired by the LMA on the waterside slope of the levee looking downstream.	
pkazi_f_20121118_080.jpg

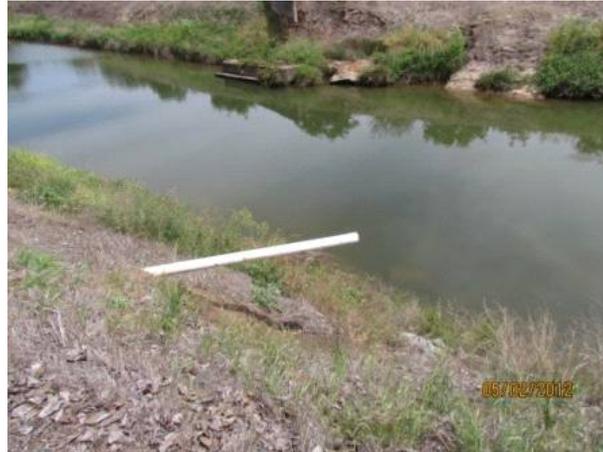
Levee Mile Report Line	136
Start Levee Mile	9.76
End Levee Mile	9.76
Location	Water Side
Category	Earthen Levee
Item	Encroachments
A perforated PVC pipe was found on the waterside slope of the levee looking upstream.	
pkazi_f_20120913_387.jpg

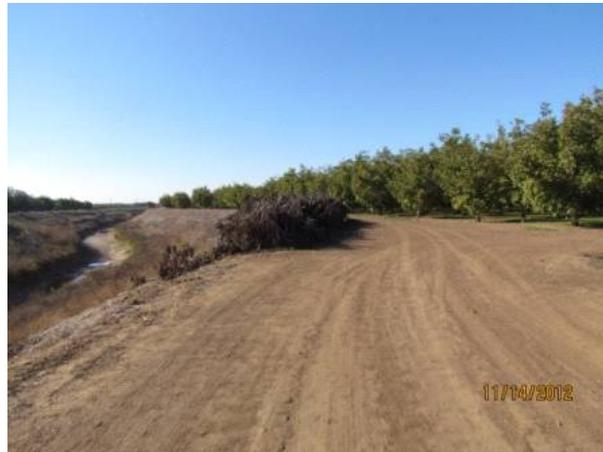
Levee Mile Report Line	137
Start Levee Mile	10.01
End Levee Mile	10.01
Location	Water Side
Category	Earthen Levee
Item	Encroachments
Prunings were found on the waterside shoulder of the levee looking downstream.	
pkazi_f_20121118_081.jpg

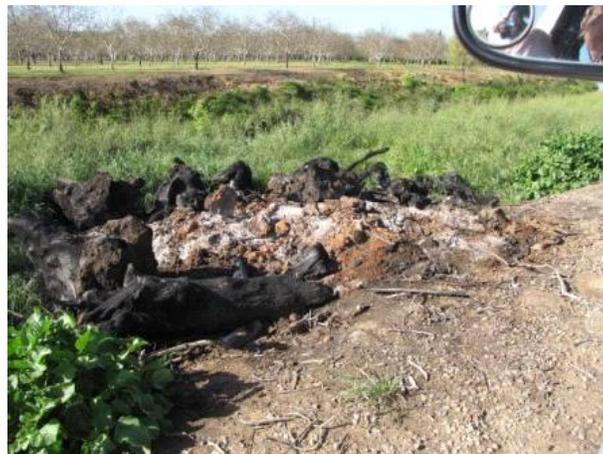
Levee Mile Report Line	139
Start Levee Mile	10.62
End Levee Mile	10.62
Location	Water Side
Category	Earthen Levee
Item	Encroachments
View of the prunings pile on the waterward slope looking downstream.	
pkazi_f_20120913_351.jpg

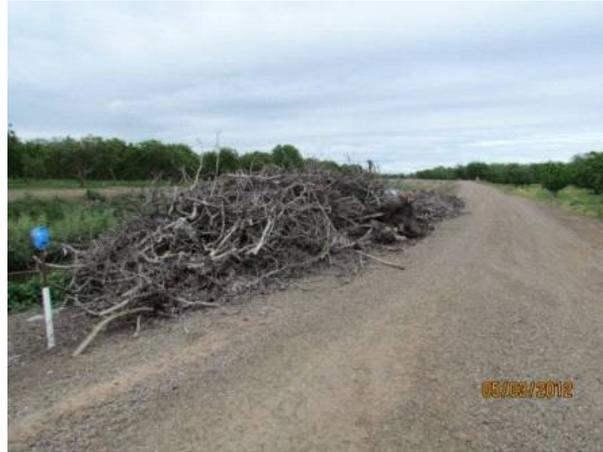
Levee Mile Report Line	139
Start Levee Mile	10.62
End Levee Mile	10.62
Location	Water Side
Category	Earthen Levee
Item	Encroachments
Prunings were found on the waterside of the levee looking downstream.	
pkazi_f_20120913_352.jpg

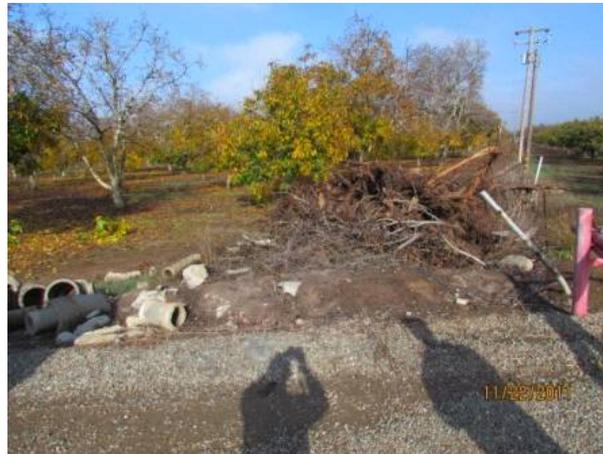
Levee Mile Report Line	140
Start Levee Mile	10.76
End Levee Mile	10.76
Location	Land Side
Category	Earthen Levee
Item	Encroachments
Prunings were found on the landside of the levee looking downstream.	
pkazi_f_20120913_414.jpg

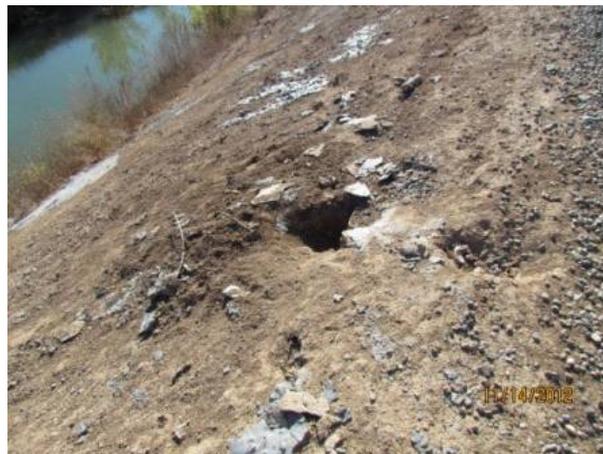
Levee Mile Report Line	142
Start Levee Mile	11.05
End Levee Mile	11.05
Location	Water Side
Category	Earthen Levee
Item	Animal Control
An animal hole was found on the waterside slope of the levee looking downstream.	
pkazi_f_20121118_082.jpg

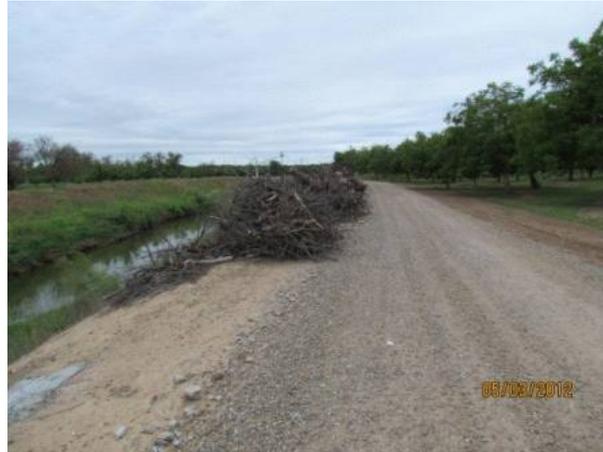
Levee Mile Report Line	143
Start Levee Mile	11.06
End Levee Mile	11.06
Location	Water Side
Category	Earthen Levee
Item	Encroachments
Prunings were found on the waterside of the levee looking downstream.	
pkazi_f_20120913_388.jpg

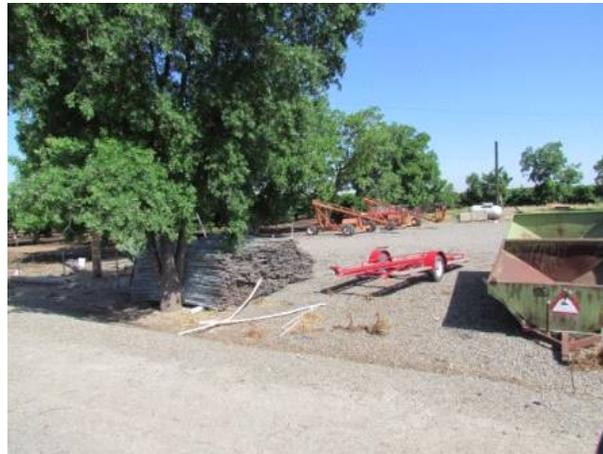
Levee Mile Report Line	144
Start Levee Mile	11.58
End Levee Mile	11.58
Location	Land Side
Category	Earthen Levee
Item	Encroachments
Equipment on the landside of the levee. The picture was taken from the crown looking downstream.	
pkazi_f_20120913_394.jpg

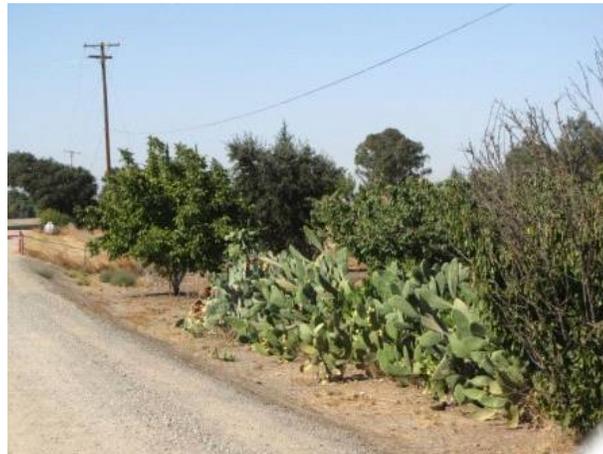
Levee Mile Report Line	145
Start Levee Mile	11.61
End Levee Mile	11.61
Location	Land Side
Category	Earthen Levee
Item	Vegetation
View of cactus within 10 feet of the landward toe blocking visibility and access.	
pkazi_f_20120913_370.jpg

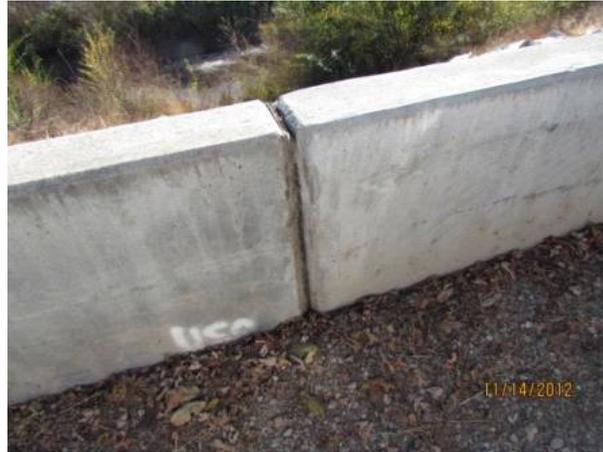
pkazi_f_20121118_083.jpg

The monolith joint material was appeared to be deteriorating located on the waterside shoulder of the levee looking downstream.

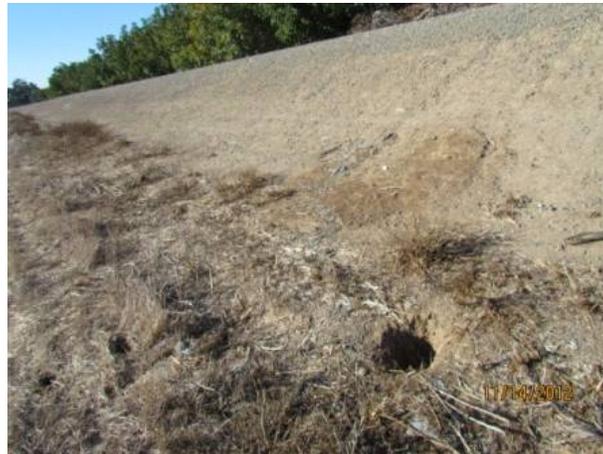
pkazi_f_20121118_084.jpg

Animal holes were found on the waterside toe of the levee looking downstream.

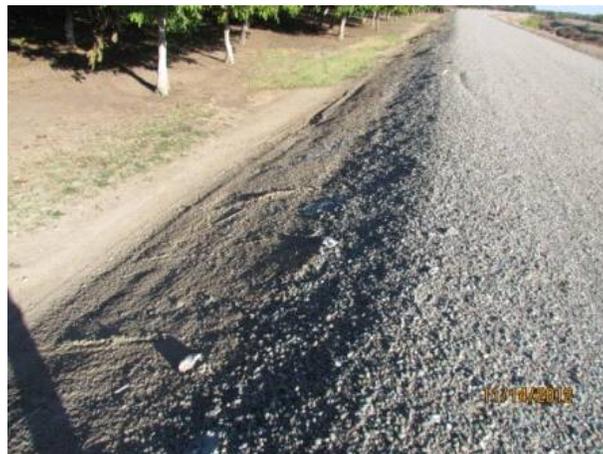
pkazi_f_20121118_085.jpg

Levee Mile Report Line	151
Start Levee Mile	12.19
End Levee Mile	12.19
Location	Land Side
Category	Earthen Levee
Item	Animal Control

Animal holes were repaired by the LMA on the landside slope of the levee looking upstream.

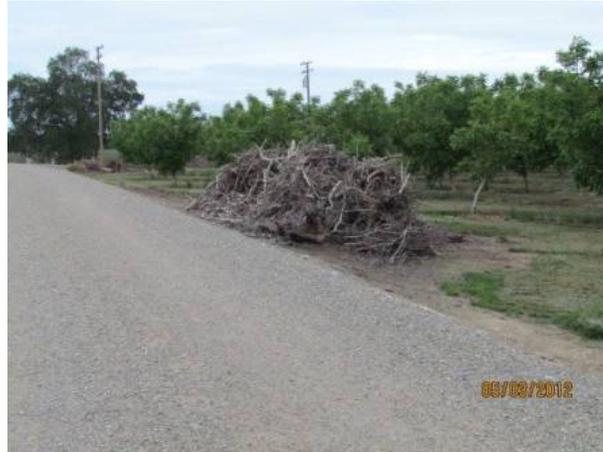
Levee Mile Report Line	152
Start Levee Mile	12.21
End Levee Mile	12.21
Location	Land Side
Category	Earthen Levee
Item	Encroachments
Prunings were found on the landside of the levee looking downstream.	
pkazi_f_20120913_326.jpg

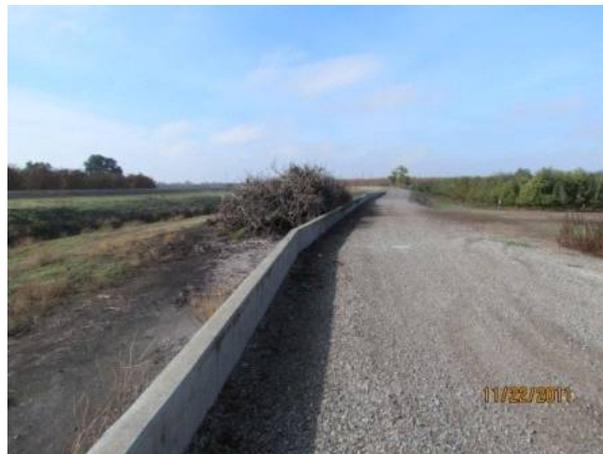
Levee Mile Report Line	154
Start Levee Mile	12.82
End Levee Mile	12.82
Location	Water Side
Category	Earthen Levee
Item	Encroachments
Prunings were found on the waterside of the levee looking downstream.	
pkazi_f_20120913_327.jpg

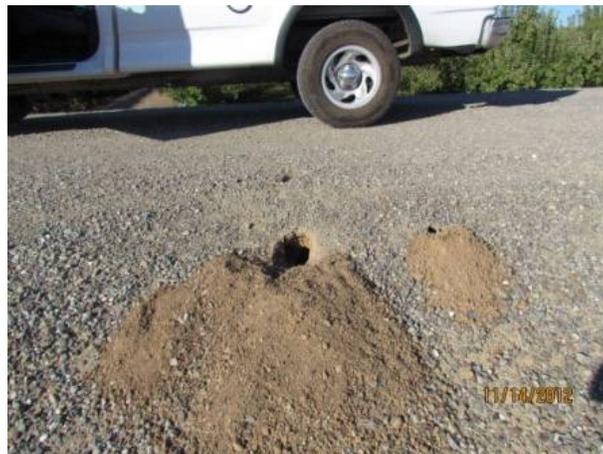
Levee Mile Report Line	155
Start Levee Mile	12.94
End Levee Mile	12.94
Location	Water Side
Category	Earthen Levee
Item	Animal Control
Animal holes were found on the waterside slope of the levee looking upstream.	
pkazi_f_20121118_086.jpg

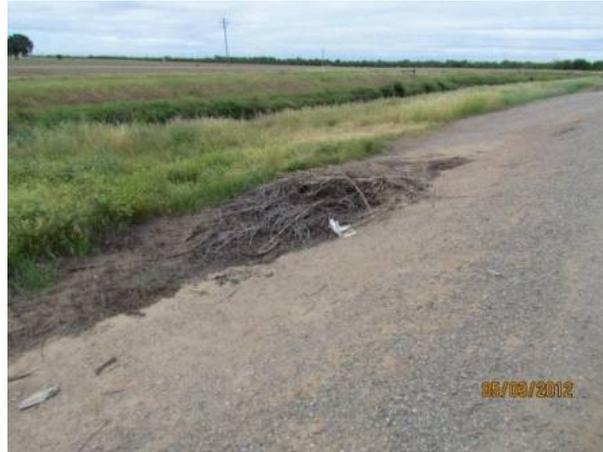
Levee Mile Report Line	156
Start Levee Mile	12.99
End Levee Mile	12.99
Location	Water Side
Category	Earthen Levee
Item	Encroachments
Prunings were found on the waterside of the levee looking downstream.	
pkazi_f_20120913_439.jpg

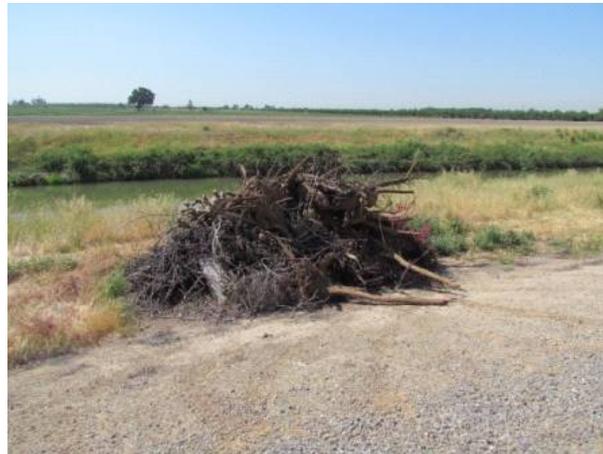
Levee Mile Report Line	157
Start Levee Mile	13.08
End Levee Mile	13.08
Location	Water Side
Category	Earthen Levee
Item	Encroachments
Pruning on the waterside of the levee looking downstream.	
pkazi_f_20120913_395.jpg

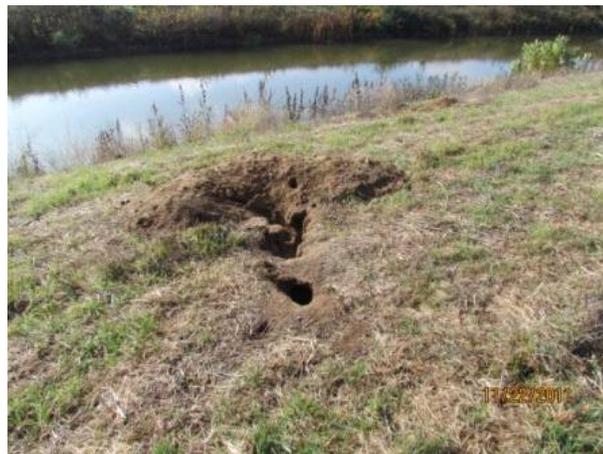
Levee Mile Report Line	158
Start Levee Mile	13.11
End Levee Mile	13.11
Location	Water Side
Category	Earthen Levee
Item	Animal Control
Rodent holes were found on the waterside of the levee looking downstream.	
pkazi_f_20120913_440.jpg

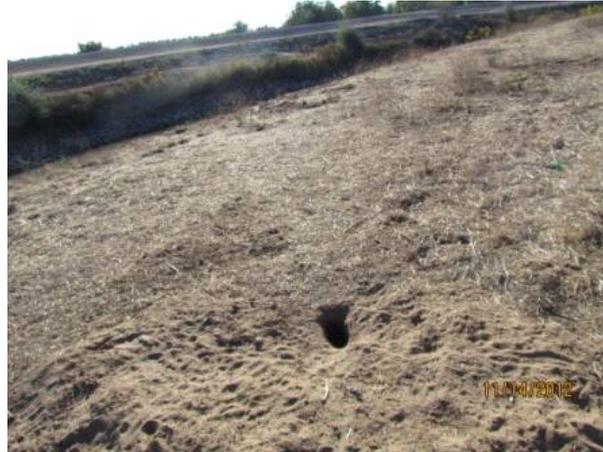
pkazi_f_20121118_087.jpg

Updated picture of the animal hole on the waterside berm of the levee looking upstream.

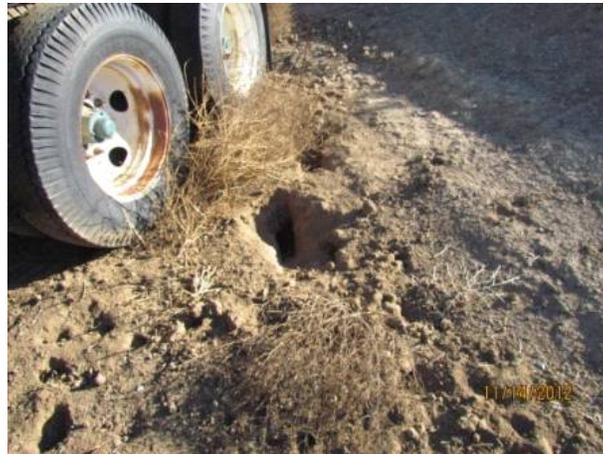
pkazi_f_20121118_088.jpg

Levee Mile Report Line	159
Start Levee Mile	13.21
End Levee Mile	13.21
Location	Land Side
Category	Earthen Levee
Item	Animal Control

View of the animal hole was located on the landside toe of the levee looking upstream.

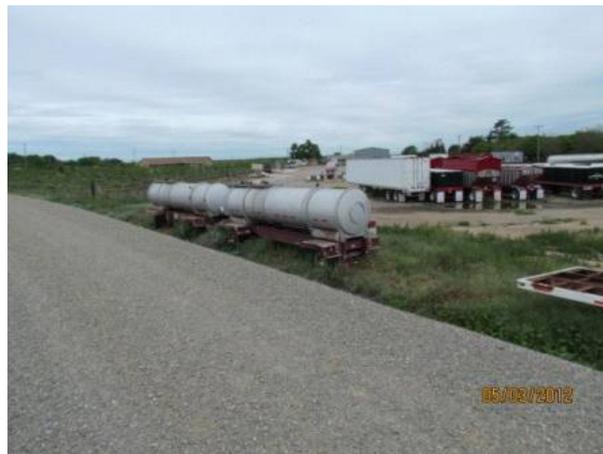
pkazi_f_20120913_374.jpg

Levee Mile Report Line	160
Start Levee Mile	13.25
End Levee Mile	13.25
Location	Land Side
Category	Earthen Levee
Item	Encroachments

Equipments were found on the landside toe of the levee looking downstream.

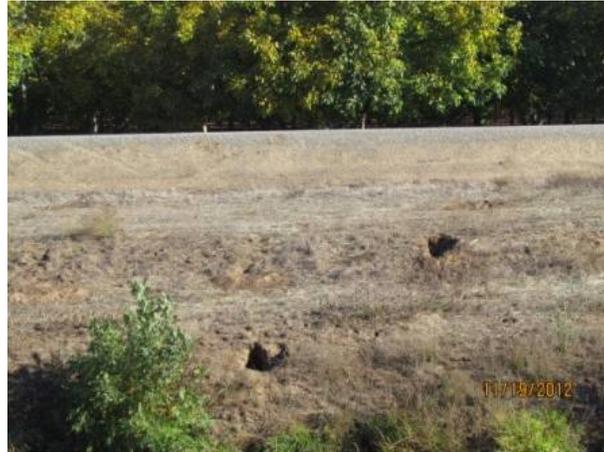
Levee Mile Report Line	161
Start Levee Mile	13.31
End Levee Mile	13.31
Location	Water Side
Category	Earthen Levee
Item	Animal Control
<p>Animal holes were found on the waterside berm of the levee looking from the opposite side of the levee.</p>	
<p>pkazi_f_20121121_099.jpg</p>

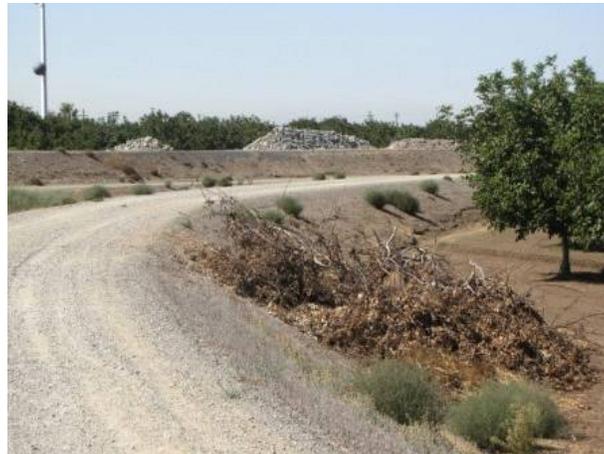
Levee Mile Report Line	163
Start Levee Mile	13.58
End Levee Mile	13.58
Location	Land Side
Category	Earthen Levee
Item	Encroachments
<p>View of a prunings pile on the landward slope looking downstream. The resident stated it would be moved in a few weeks.</p>	
<p>pkazi_f_20120913_377.jpg</p>

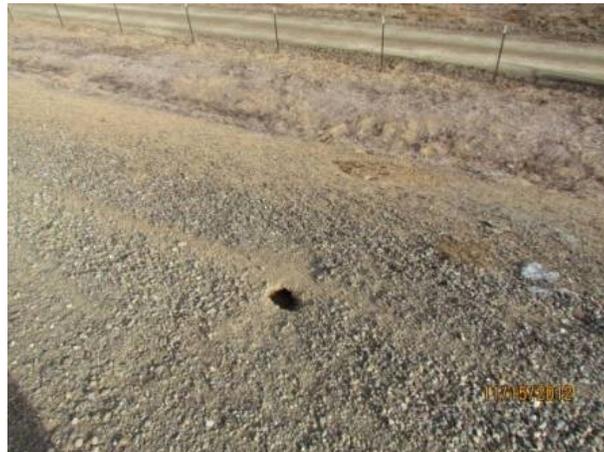
Levee Mile Report Line	164
Start Levee Mile	14.25
End Levee Mile	14.25
Location	Land Side
Category	Earthen Levee
Item	Animal Control
<p>An animal hole was found on the landside slope of the levee looking downstream.</p>	
<p>pkazi_f_20121118_089.jpg</p>

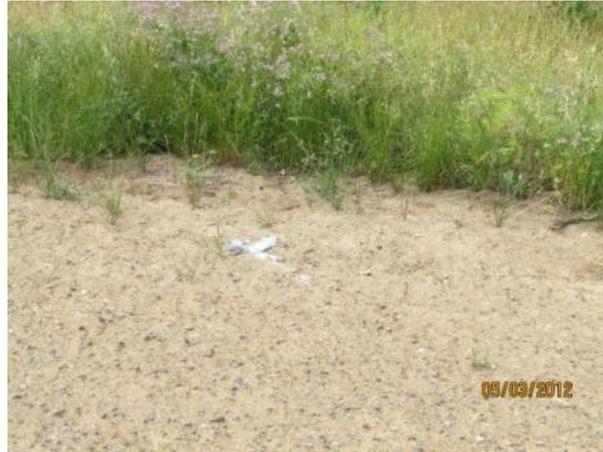
Levee Mile Report Line	165
Start Levee Mile	14.74
End Levee Mile	14.74
Location	Water Side
Category	Earthen Levee
Item	Animal Control
An existing animal hole was grouted by the LMA on the waterside of the levee looking upstream.	
pkazi_f_20120913_393.jpg

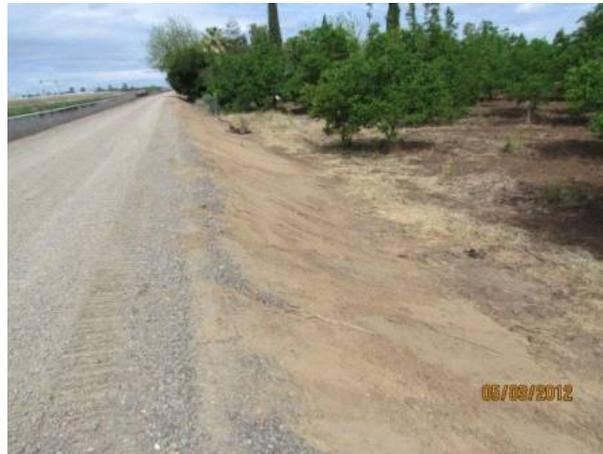
Levee Mile Report Line	167
Start Levee Mile	15.71
End Levee Mile	15.71
Location	Land Side
Category	Earthen Levee
Item	Animal Control
Existing animal holes were fixed by the LMA on the landside of the levee looking downstream.	
pkazi_f_20120913_396.jpg

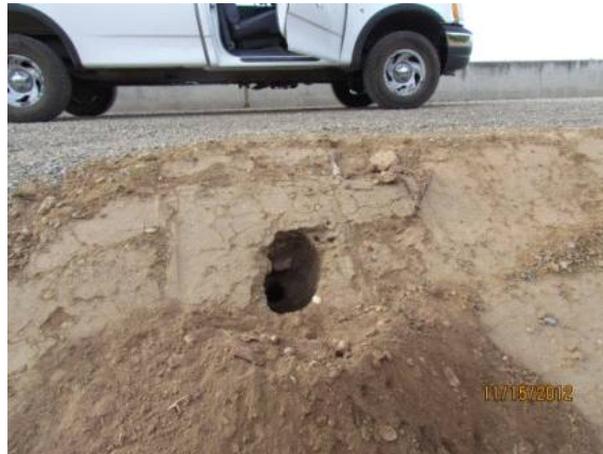
Levee Mile Report Line	168
Start Levee Mile	15.73
End Levee Mile	15.73
Location	Land Side
Category	Earthen Levee
Item	Animal Control
An animal hole was found on the landside slope of the levee looking downstream.	
pkazi_f_20121118_090.jpg

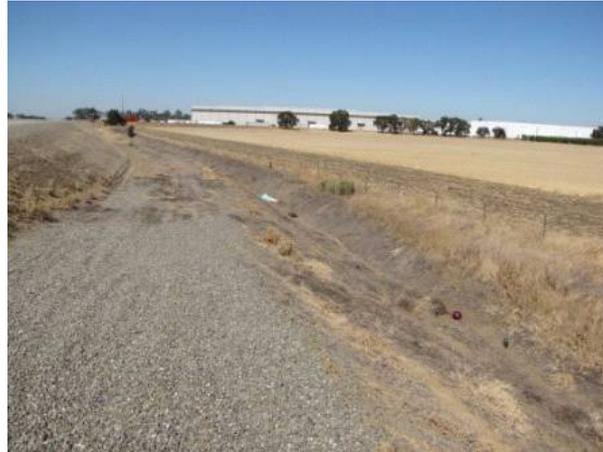
Levee Mile Report Line	169
Start Levee Mile	16.09
End Levee Mile	16.60
Location	Land Side
Category	Earthen Levee
Item	Encroachments
View of a ditch adjacent to the landward toe looking downstream.	
pkazi_f_20120913_415.jpg

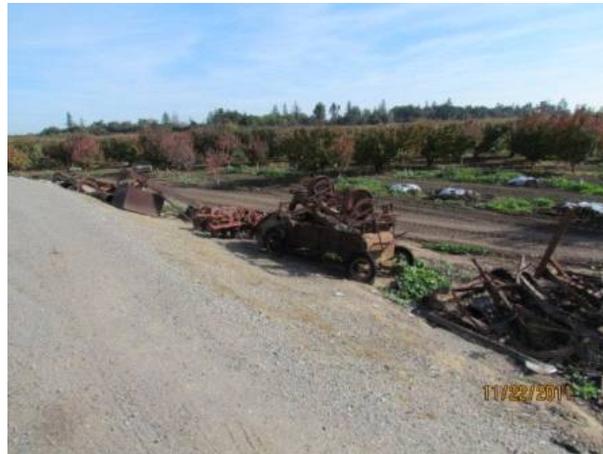
Levee Mile Report Line	174
Start Levee Mile	18.44
End Levee Mile	18.44
Location	Land Side
Category	Earthen Levee
Item	Encroachments
Equipment was found on the landside of the levee looking downstream.	
pkazi_f_20120913_407.jpg

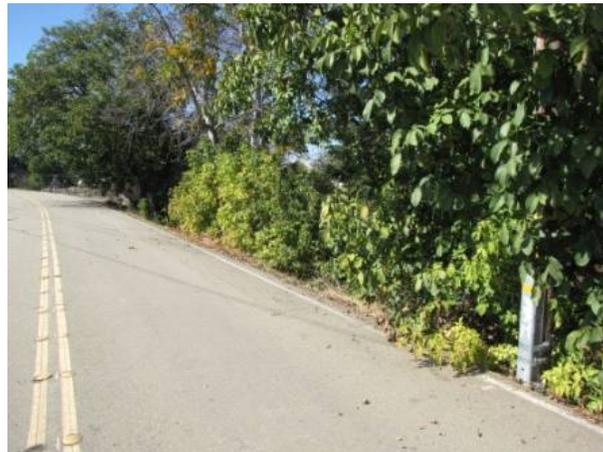
Levee Mile Report Line	175
Start Levee Mile	18.54
End Levee Mile	18.55
Location	Land Side
Category	Earthen Levee
Item	Vegetation
View of landowner planted and maintained vegetation along the landward slope looking downstream.	
pkazi_f_20120913_417.jpg

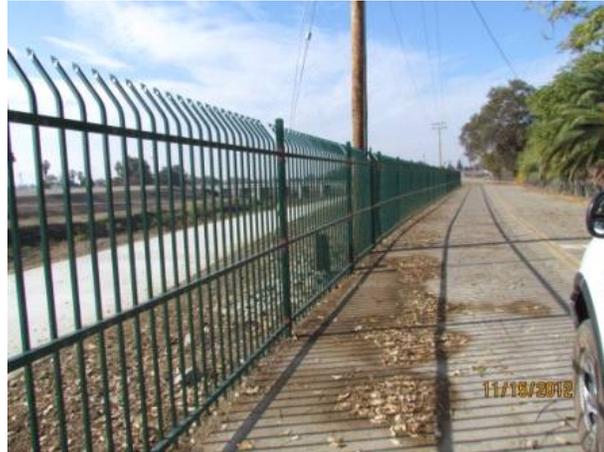
pkazi_f_20121118_091.jpg

A fence was placed by the City of Stockton on the waterside shoulder of the levee looking downstream.

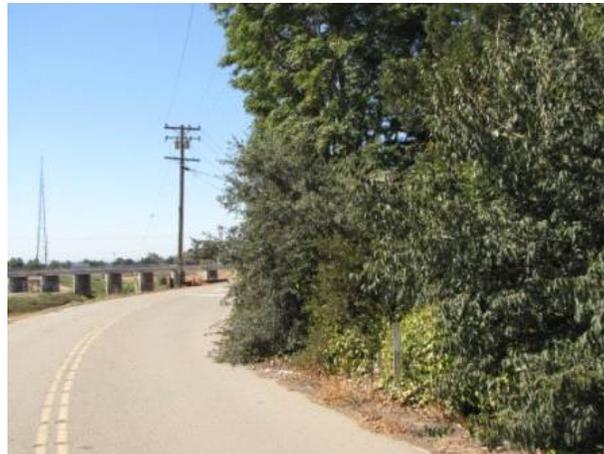
pkazi_f_20120913_418.jpg

Levee Mile Report Line	178
Start Levee Mile	19.80
End Levee Mile	19.86
Location	Land Side
Category	Earthen Levee
Item	Vegetation

View of landowner planted and maintained vegetation along the landward slope looking downstream.

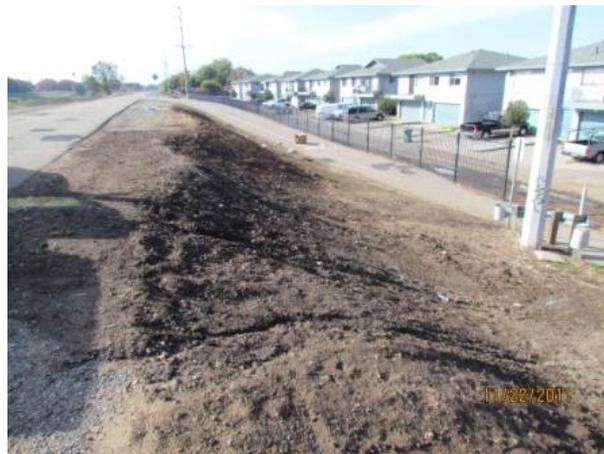
pkazi_f_20120913_416.jpg

Levee Mile Report Line	179
Start Levee Mile	20.64
End Levee Mile	20.64
Location	Land Side
Category	Earthen Levee
Item	Slope Stability

Erosion was found on the landside of the levee looking downstream.

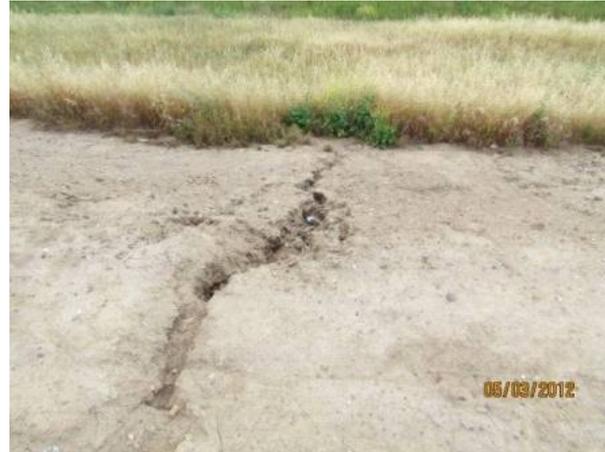
Levee Mile Report Line	181
Start Levee Mile	20.80
End Levee Mile	20.80
Location	Water Side
Category	Earthen Levee
Item	Erosion / Bank Caving
Erosion was found on the waterside of the levee looking downstream.	
pkazi_f_20120913_397.jpg

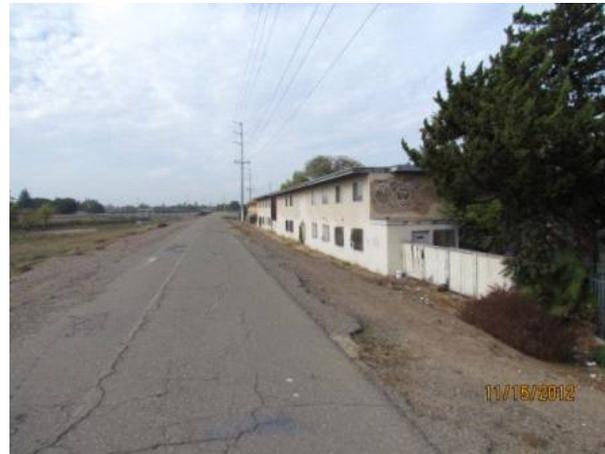
Levee Mile Report Line	182
Start Levee Mile	20.91
End Levee Mile	21.01
Location	Land Side
Category	Earthen Levee
Item	Encroachments
View of the buildings on the landside of the levee looking downstream.	
pkazi_f_20121118_092.jpg

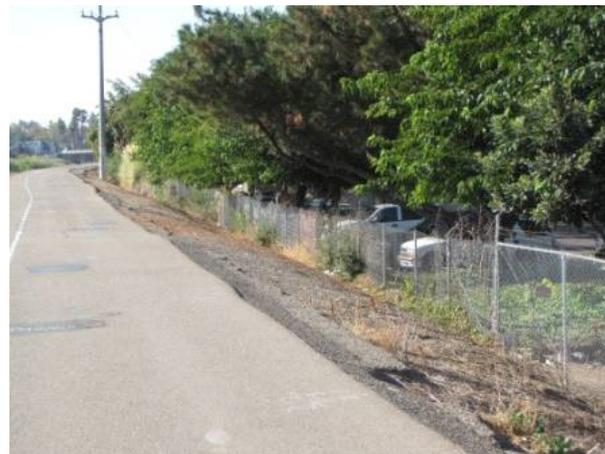
Levee Mile Report Line	187
Start Levee Mile	21.46
End Levee Mile	21.61
Location	Land Side
Category	Earthen Levee
Item	Encroachments
View of fence along the landward toe looking downstream.	
pkazi_f_20120913_419.jpg

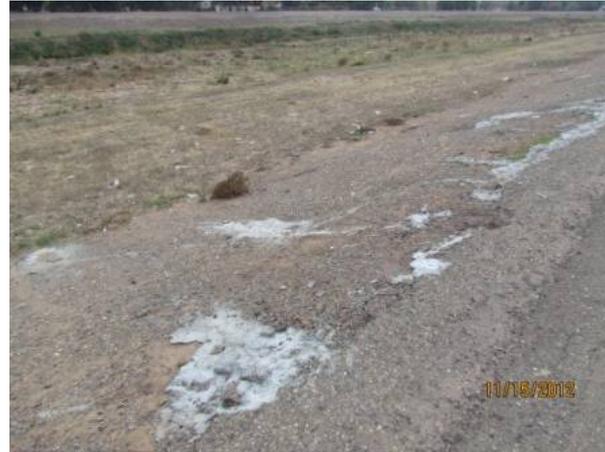
Levee Mile Report Line	188
Start Levee Mile	21.47
End Levee Mile	21.47
Location	Water Side
Category	Earthen Levee
Item	Animal Control
<p>The animal holes were repaired by the LMA on the waterside slope of the levee looking downstream.</p>	
<p>pkazi_f_20121118_093.jpg</p>

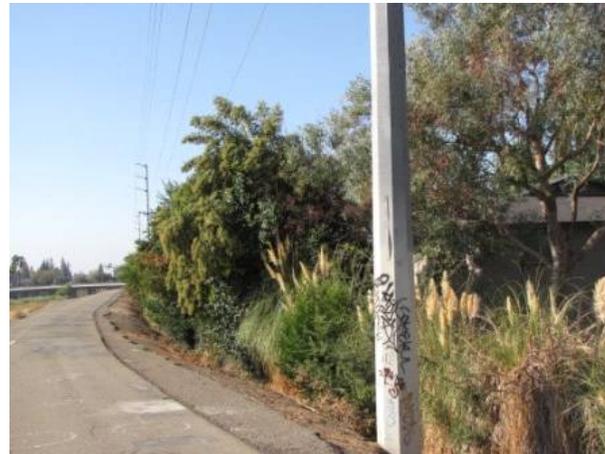
Levee Mile Report Line	189
Start Levee Mile	21.52
End Levee Mile	21.73
Location	Land Side
Category	Earthen Levee
Item	Vegetation
<p>View of landscaping along the landward slope and toe looking downstream.</p>	
<p>pkazi_f_20120913_333.jpg</p>

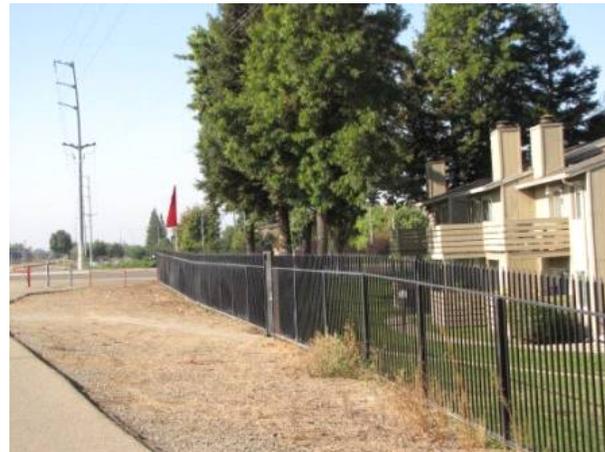
Levee Mile Report Line	190
Start Levee Mile	21.73
End Levee Mile	21.77
Location	Land Side
Category	Earthen Levee
Item	Encroachments
<p>View of fence along the landward shoulder looking downstream.</p>	
<p>pkazi_f_20120913_420.jpg</p>

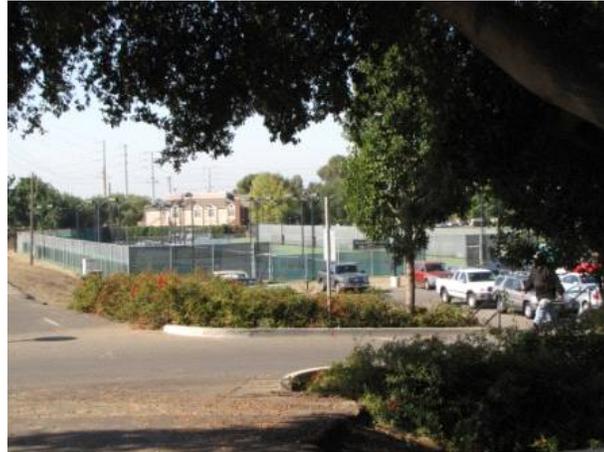
pkazi_f_20120913_421.jpg

View of landscaping maintained by UOP along the landward slope looking downstream.

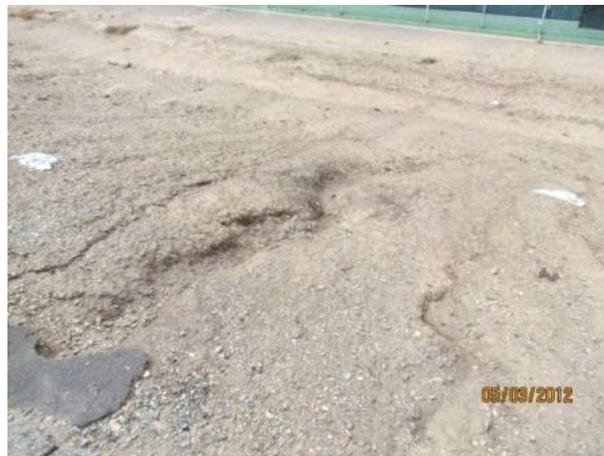
pkazi_f_20120913_401.jpg

Levee Mile Report Line	192
Start Levee Mile	22.17
End Levee Mile	22.17
Location	Land Side
Category	Earthen Levee
Item	Erosion / Bank Caving

Erosion was found due to runoff on the landside of the levee looking downstream.

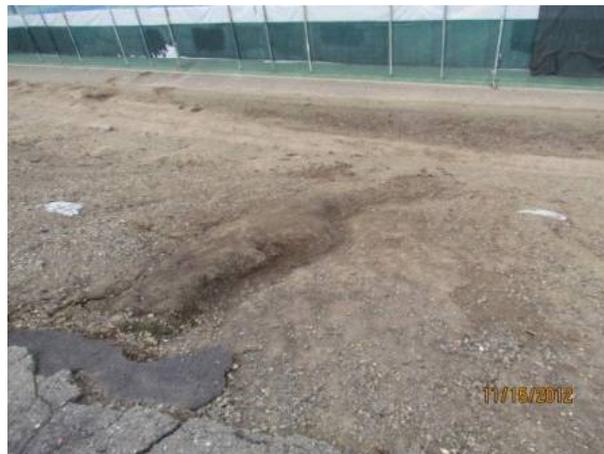
pkazi_f_20121118_094.jpg

Levee Mile Report Line	192
Start Levee Mile	22.17
End Levee Mile	22.17
Location	Land Side
Category	Earthen Levee
Item	Erosion / Bank Caving

Updated picture of the erosion located on the landside of the levee looking downstream.

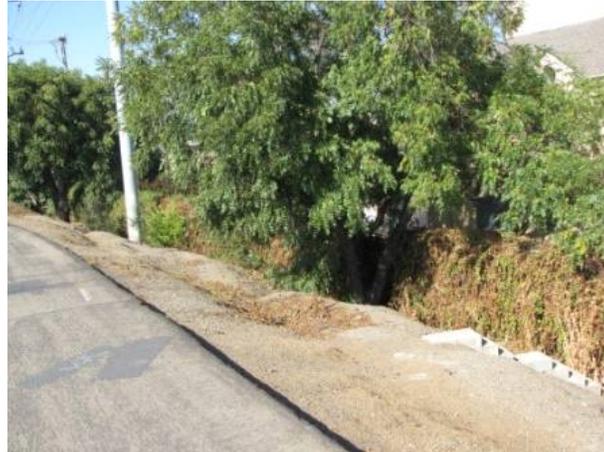
pkazi_f_20120913_334.jpg

View of landscaping along the landward toe of the levee looking downstream.

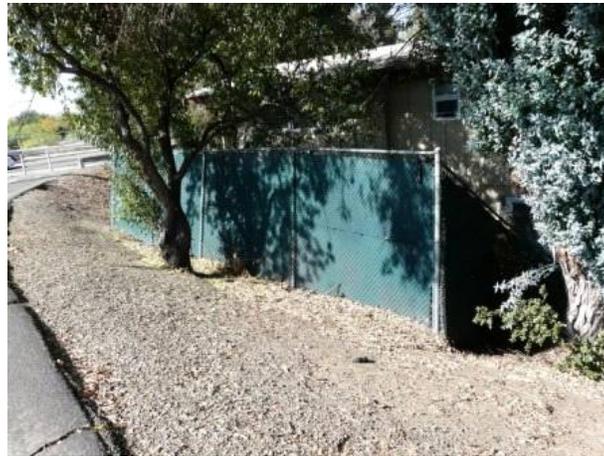
pkazi_f_20120913_364.JPG

Levee Mile Report Line	194
Start Levee Mile	22.36
End Levee Mile	22.37
Location	Land Side
Category	Earthen Levee
Item	Encroachments

Fence located from LM 22.36 to LM 22.37 significantly encroaches onto landside levee slope.

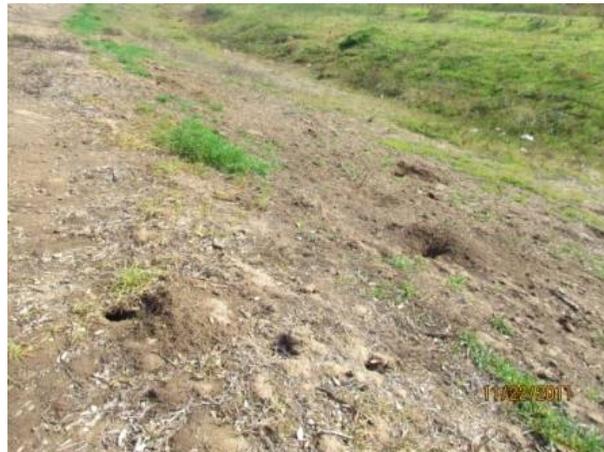
DWR ID: DWR_NA0017_07_s_2012_784										
44	4.66	5.63	Earthen Levee	Encroachments	LS	M En	FE : Fence	38.045023 ° -121.294989 °	38.052709 ° -121.281584 °	785 Y
DWR ID: DWR_NA0017_07_s_2012_785

Rodent holes were found on the waterside of the levee looking upstream.

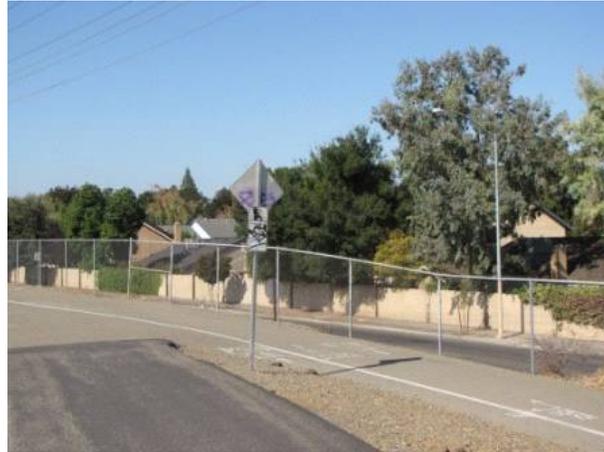
pkazi_f_20120913_422.jpg

View of fence along the landward shoulder looking downstream.

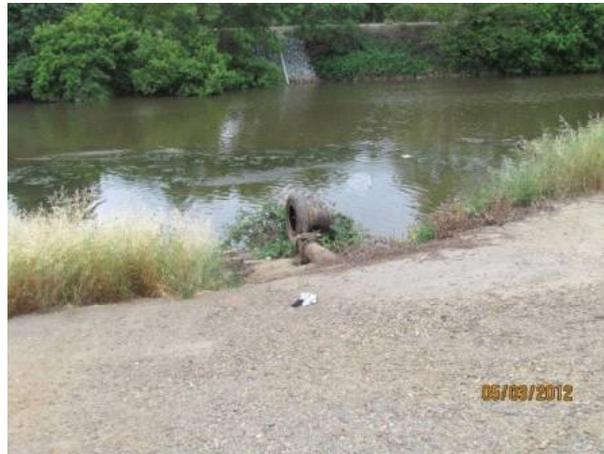
pkazi_f_20120913_403.jpg

Levee Mile Report Line	197
Start Levee Mile	23.45
End Levee Mile	23.45
Location	Water Side
Category	Earthen Levee
Item	Encroachments

An abandoned pump and pipe was found on the waterside of the levee looking downstream.

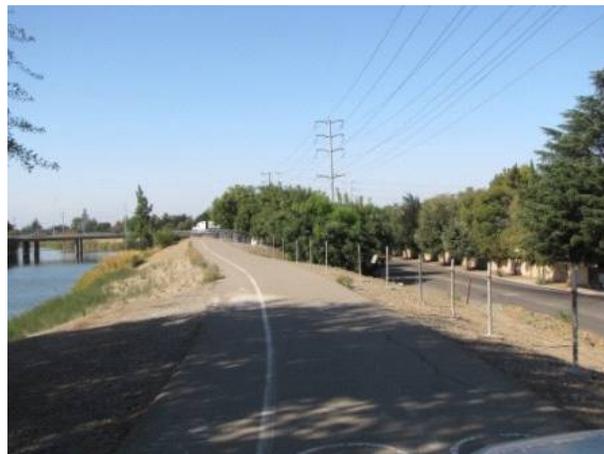
pkazi_f_20120913_423.jpg

Levee Mile Report Line	198
Start Levee Mile	23.54
End Levee Mile	23.69
Location	Land Side
Category	Earthen Levee
Item	Encroachments

View of fence along landward shoulder looking downstream.

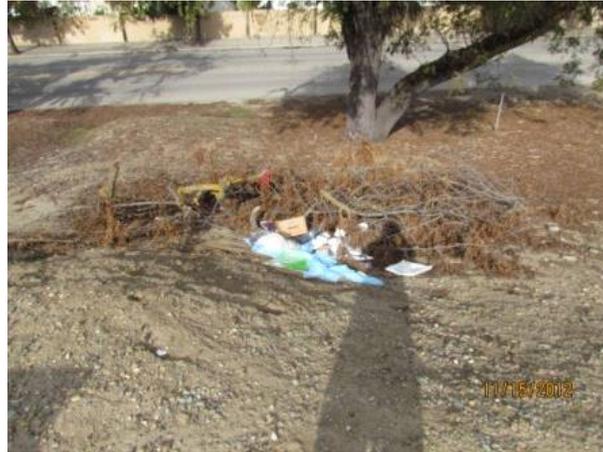
Levee Mile Report Line	199
Start Levee Mile	23.63
End Levee Mile	23.63
Location	Land Side
Category	Earthen Levee
Item	Encroachments
Debris was found on the landside slope of the levee looking downstream.	
pkazi_f_20121118_095.jpg

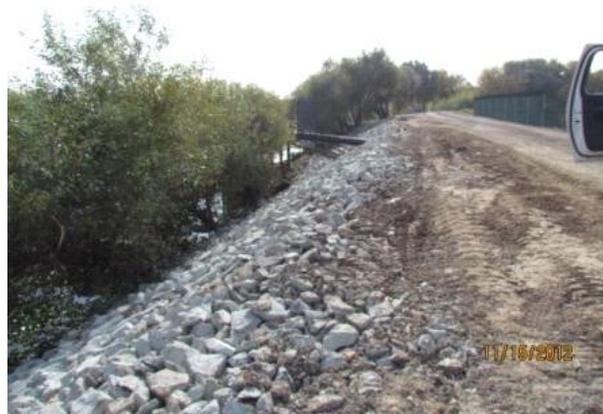
Levee Mile Report Line	202
Start Levee Mile	24.18
End Levee Mile	24.18
Location	Water Side
Category	Earthen Levee
Item	Riprap Revetments
Revetments were placed by the LMA on the waterside slope of the levee looking downstream.	
pkazi_f_20121118_096.jpg

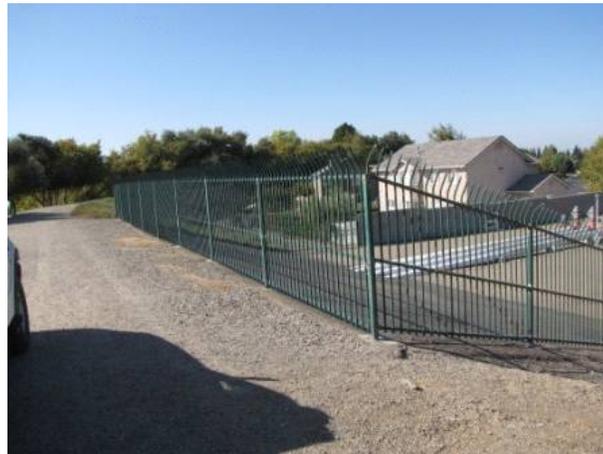
Levee Mile Report Line	203
Start Levee Mile	24.20
End Levee Mile	24.21
Location	Land Side
Category	Earthen Levee
Item	Encroachments
View of fence along the landward shoulder looking downstream.	
pkazi_f_20120913_424.jpg

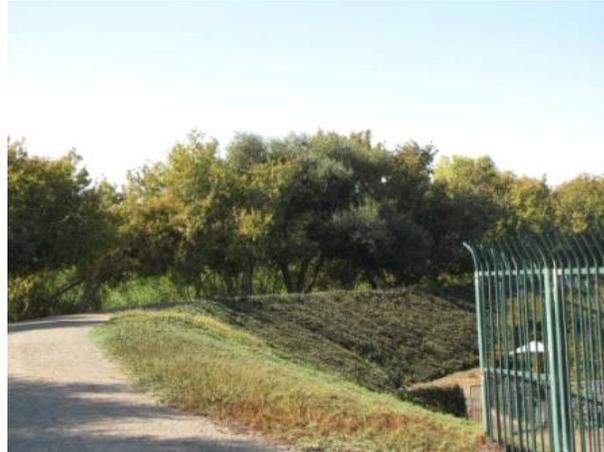
pkazi_f_20120913_335.jpg

View of typical landowner planted and maintained landscaping and irrigation along the landward shoulder, and toe looking downstream.

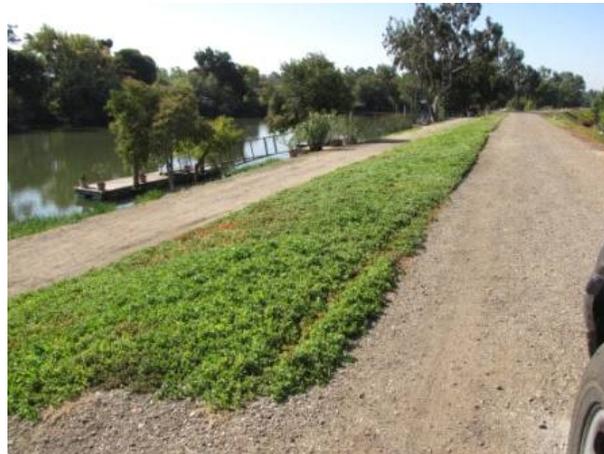
pkazi_f_20120913_425.jpg

Levee Mile Report Line	205
Start Levee Mile	24.65
End Levee Mile	25.59
Location	Water Side
Category	Earthen Levee
Item	Vegetation

View of typical landowner planted and maintained landscaping and irrigation along the waterward shoulder and slope looking downstream.

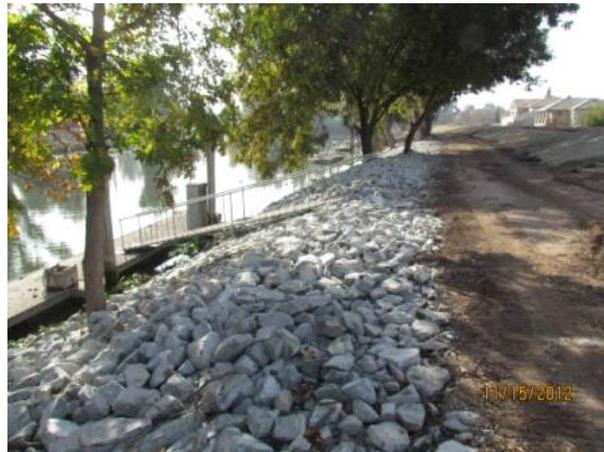
pkazi_f_20121118_097.jpg

Levee Mile Report Line	206
Start Levee Mile	24.84
End Levee Mile	24.84
Location	Water Side
Category	Earthen Levee
Item	Riprap Revetments

Revetments were placed by the LMA on the waterside slope of the levee looking downstream.

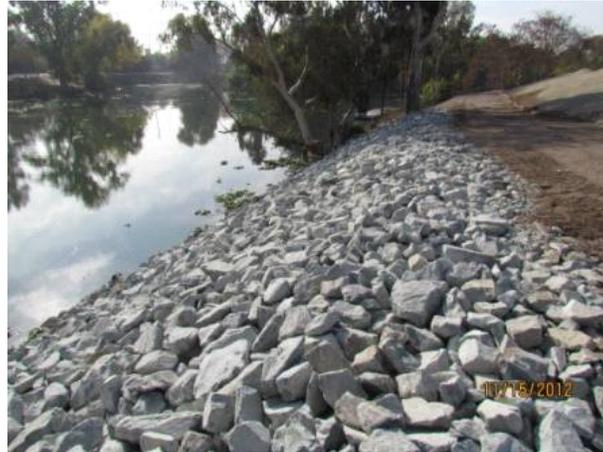
Levee Mile Report Line	214
Start Levee Mile	25.00
End Levee Mile	25.00
Location	Water Side
Category	Earthen Levee
Item	Riprap Revetments
Revetments were placed by the LMA on the waterside slope of the levee looking downstream.	
pkazi_f_20121118_098.jpg

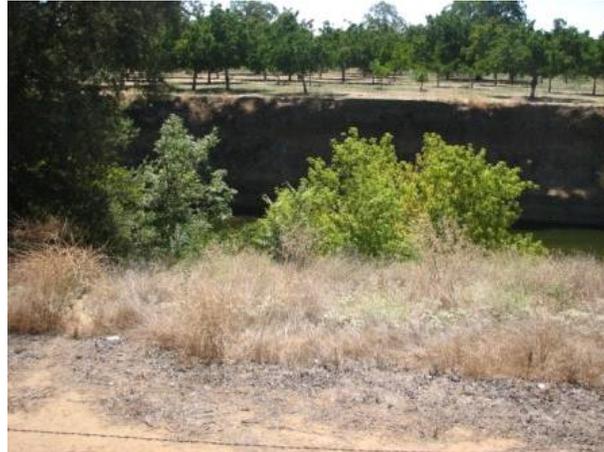
SJR2012_NA0017U16RM23.35_1.jpg

Front view of erosion. Looking from the right side of the river.

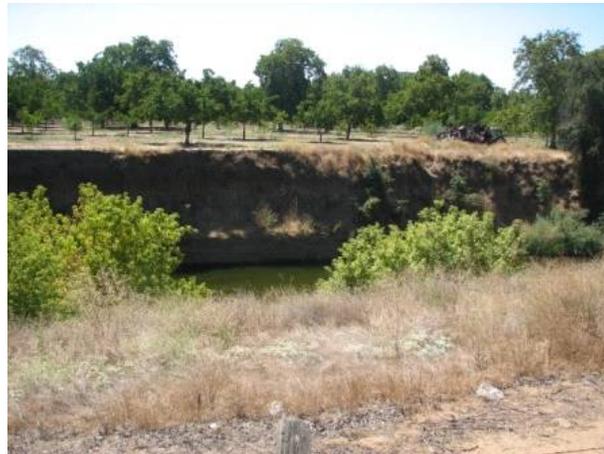
SJR2012_NA0017U16RM23.35_2.jpg

Levee Mile Report Line	2
Start Levee Mile	0.13
End Levee Mile	0.47
Location	Water Side
Category	Supplemental
Item	DWR Erosion Survey

Looking downstream standing on the right side river bank.

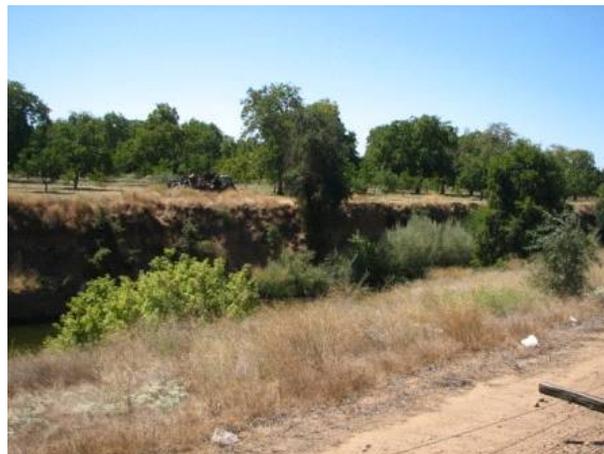
SJR2012_NA0017U16RM23.35_3.jpg

Levee Mile Report Line	2
Start Levee Mile	0.13
End Levee Mile	0.47
Location	Water Side
Category	Supplemental
Item	DWR Erosion Survey

Looking downstream from right side of the river

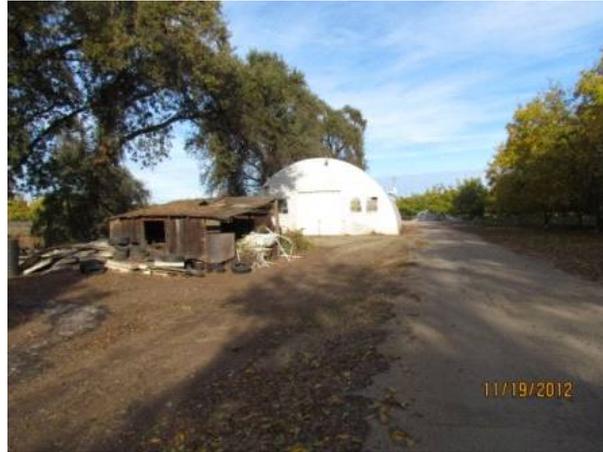
pkazi_f_20121121_147.jpg

A building was located on the waterside shoulder of the levee looking upstream.

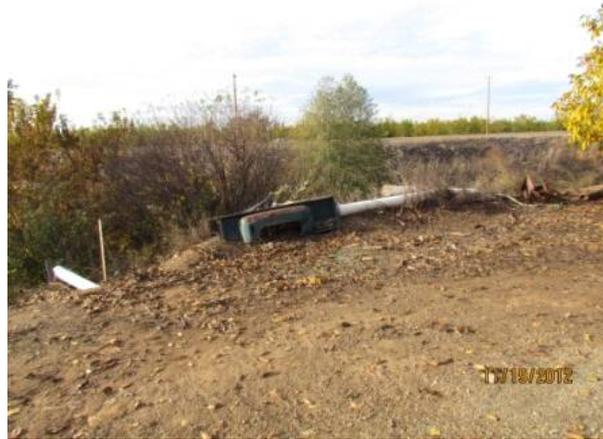
pkazi_f_20121121_146.jpg

Levee Mile Report Line	8
Start Levee Mile	0.81
End Levee Mile	0.81
Location	Water Side
Category	Earthen Levee
Item	Encroachments

Debris was found on the waterside shoulder of the levee looking upstream.

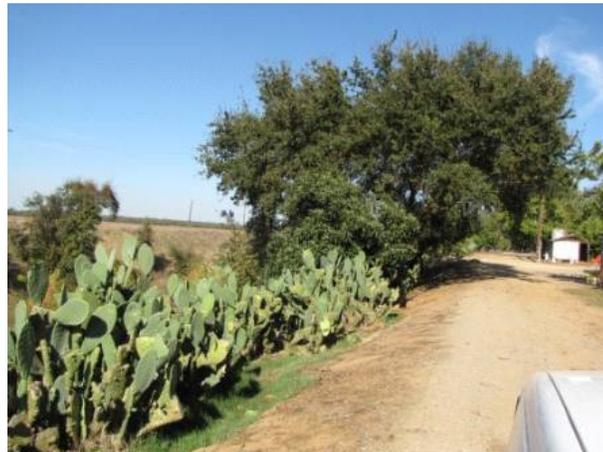
pkazi_f_20120913_540.jpg

DWR ID: DWR_NA0017_16_s_2012_72										
10	0.83	0.89	Earthen Levee	Vegetation	WS	M	V6 : Landscaping	38.044312 ° -121.024377 °	38.043691 ° -121.024946 °	179 Y
DWR ID: DWR_NA0017_16_s_2012_179										
11	0.97	0.99	Supplemental	DWR Erosion Survey	WS	U	Inspector Comments: 08/22/2012: The erosion was surveyed and documented for monitoring purpose. There is no levee structure on the site, only high ground protecting the land behind.. There is a drainage pipe at the site, which might have caused the problem at one pocket erosion. [2012 Site ID:NA0017U16RM22.74]	38.043080 ° -121.026280 °	38.043080 ° -121.026280 °	233 Y
DWR ID:

Levee Mile Report Line	10
Start Levee Mile	0.83
End Levee Mile	0.89
Location	Water Side
Category	Earthen Levee
Item	Vegetation

View of landowner maintained landscaping on waterward side looking upstream.
